Max1025 transducer preparation for F3B/F3J launch analysis

by Francesco Meschia

F3B or F3J launch tension logging may be a demanding application for the Max1025 tension transducer. Even if the transducer itself is rugged and well capable of withstanding the forces experienced during launch, some extra precautions can be taken to ensure that linkages and connections are protected and stay safe even when something goes wrong.

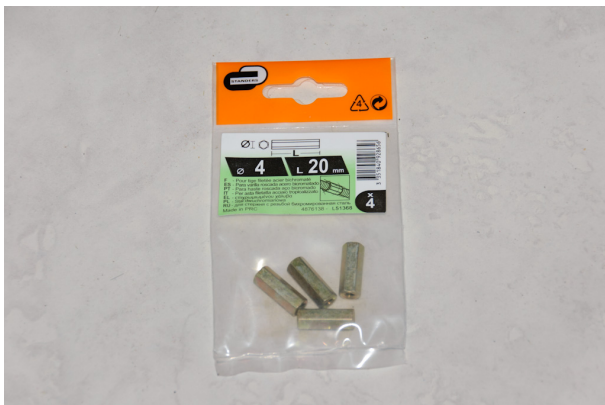
Fig. 1 - 20 mm M4 threaded steel nuts

We found that such requirements can be met by using two loops of nylon cord secured to the two force rods of the transducer with the help of two 20 mm long M4 hex nuts, locked in position by two M4 nylon lock nuts and bored at the end farthest from the transducer with a suitable drill bit, so that the nylon cord may be easily inserted through the bore. The edges of the holes must be deburred so to reduce wear on the cord. The cord can then be fastened into a loop with a suitable knot (such as a Fisherman's knot).

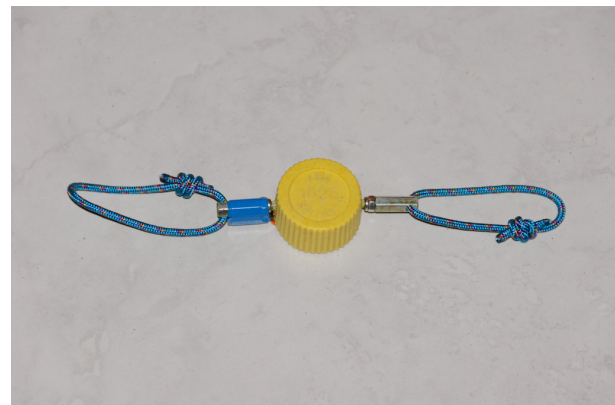
Fig. 2 – Max1025 with nylon lock nuts, coupling nuts and nylon cord loops installed

It is recommended to periodically check that the lock nuts and the coupling nuts are tight and that

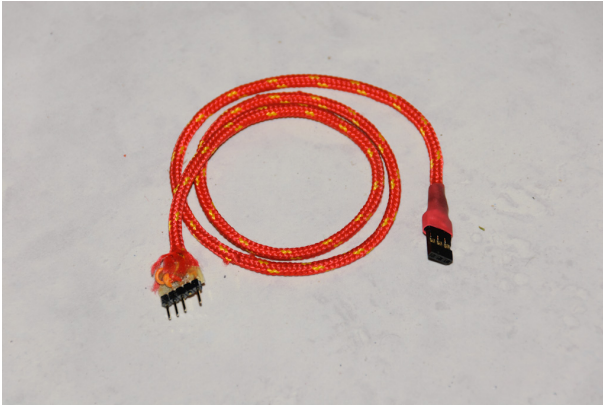
Fig. 4 - the signal cable, protected with a sleeve, with the separation connector (still “naked”) at one end, and a servo plug CA-bonded to the sleeve and covered in heat shrink tubing at the other end

The cable may also be protected from damage by sliding it through a length of nylon sleeve (of the kind commonly used to protect loops and knots in F3B and F3J lines): the sleeve may be made somewhat loose at both ends, so that it may be glued with cyanoacrylate to the connector, or covered in hot-melt glue or epoxy resin to make a connector shell. The use of a sleeve will increase the aerodynamic drag experienced by the cable (though the increase will still be marginal in comparison to the overall line drag), and this may lead to premature disconnection: to avoid this situation, the cable may be routed along the parachute lines and through the parachute apex opening.
